3.0 PHYSICAL ANALYSIS

3.1 GENERAL DESCRIPTION OF GOAT ISLAND

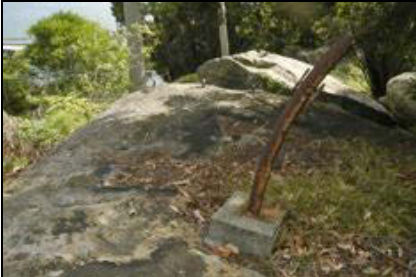
The signal mast set in a prominent location with clear views down the harbour comprised a steel post, now cut down, two sets of three guy points for signal ropes and four corner fixing points for stays. All of the fixings remain.	
140	1930s c	Monterey Pine (<i>Pinus radiata</i>)

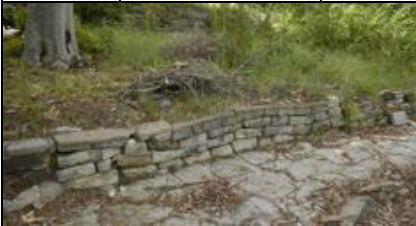
A network of paths extends through the precinct with a number of stone flagged paths, now in poor condition, dating from the later period of occupation. The paths along the northern edge are related to gardens that extended onto the rock edge and include stone retaining walls, steps and various decorative features.

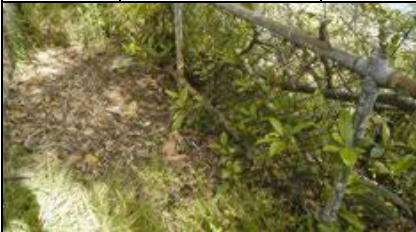
-	Post 1940s	Fences	Fences to public areas	Poor

A range of fences from steel tube and mesh to painted timber post and rail are located throughout the precinct at stairs and to protect edges alongside access paths. Most fences are deteriorated and the paths overgrown.		
129	1970s-1980s	Navigation markers	Intact	Good

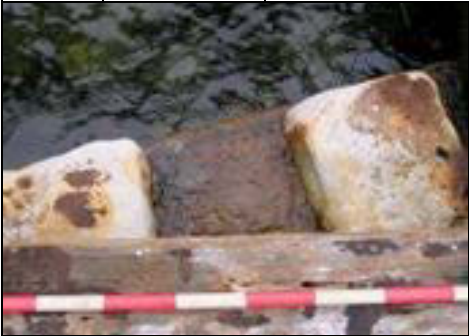
Item No	Date	Name	Level of intactness	Condition
Pre-Contact Period				
-	-	-	-	-
Colonial Period				
98	1835c	Stone jetty	Archaeological site, partially intact	n/a

<p>Wharf constructed of stone blocks partially visible extending from under the partially demolished timber wharf (55b). This area has been filled but originally served as the water police wharf from 1836.</p> <p>North at top. The edge of the early wharf now forms part of the sea wall.</p>		
Maritime Period: Sydney Harbour Trust Phase				
82	1901	Stone block sea wall	Largely intact	Fair
		<p>Built as an extension of the Cut wall, this appears to be the first stone wall built by the Harbour Trust as they set up their wharves and infrastructure in 1901. Now built over it remains in reasonable condition.</p>		
83	1901+	Quarry and quarry face	Largely intact	Fair

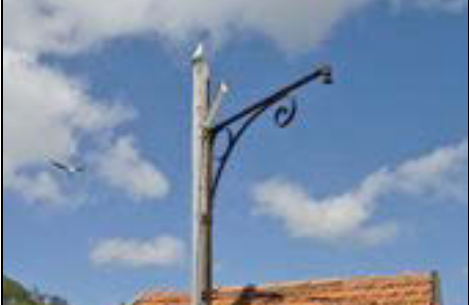
128	1920s	Light bracket	Largely intact	Fair/poor

<p>A decorative steel light bracket fitted to a timber power pole on the ferry wharf that predates the present wharf construction and appears to date from the Maritime Period: SHT phase. It has a new light fitted directly above it.</p>

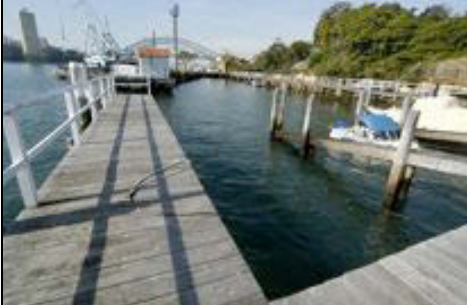
Item No	Date	Name	Level of intactness	Condition
54b	1941-43	Small Boat Enclosure	Largely intact	Good

<p>The boat pens are located behind the ferry wharf and have been reconstructed a number of times, more recently in 1995 and again around 2005. The walkway and pens are in sound condition and are used to moor NPWS operational vessels. The remaining structures comprise a walkway supported on pairs of 350mm diameter piles with 350 x 350mm headstocks and 300 x 300 girders, 100mm deep timber decking with a painted timber handrail to the shore side (and Harbour side of the outer section), timber ladders providing access to small vessels that may be moored alongside and a series of pens with sloped access ramps, reconstructed as originally constructed. Various additions to this area have collapsed or been removed over time. A corner pile is missing from the walkway.</p> <p>A small shed remains at the western end of the pens supported on four detached piles and framing. It is a movable structure.</p> <p>An attached walkway and stair connecting to the top of the rock escarpment is known as the Harbour Master's Stair. It now forms part of the boat pen area but formerly, before the construction of the boat pens, connected to a separate wharf. The stair has collapsed and the walkway is in poor condition.</p>

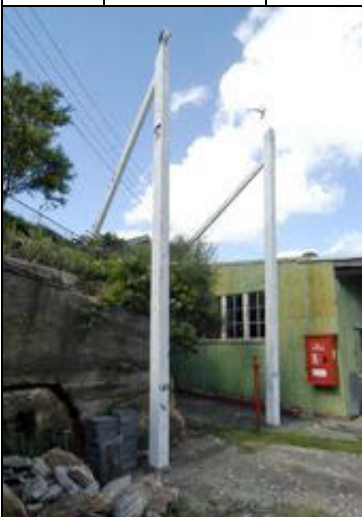
125	1940s	Fire brigade gallows	Partial remains	Poor

The fire brigade gallows remains only in part, missing its cross rails and braces. Used to hang drying hoses it also had pulleys and ropes. It was an essential part of the fire brigade infrastructure. It was braced back to the rock face and was adjacent to a timber access stair.

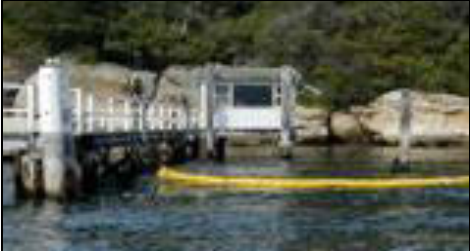
Item No	Date	Name	Level of intactness	Condition
130	1945c	Shed	Largely intact	Fair/poor

<p>A small timber shed that has been relocated a number of times around the wharves and has had a range of uses. It is a basic and simple structure of timber framing and timber cladding.</p>		
127	1945c	Waiting Shed	Largely intact	Fair/poor

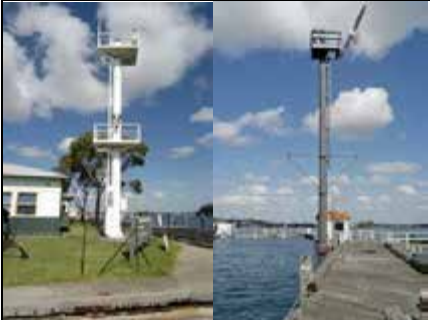
<p>Front and rear tanker leads for tankers entering Gore Cove (day and night). One is on the ferry wharf and one on the corner of the filled area of the island. They replace earlier markers in similar locations. Date known from an MSB plan.</p>

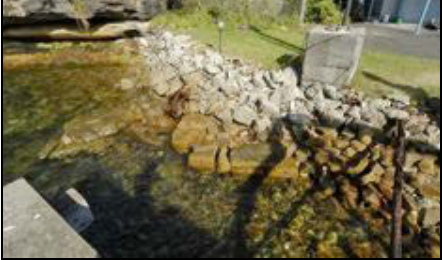
The remains of the first stone jetty on the island related to the first quarry remain under later fill for the infilling of the area for the 1914 wharf and crane construction. Comprising large stone blocks it is likely that most of the early structure remains under the current fill.

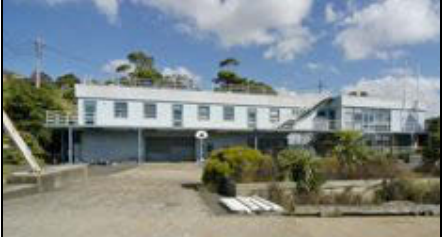
The Port Emergency Services Building is a modern steel framed structure with lightweight infill walls, concrete decks and a membrane covered flat roof used as an observation deck. It was the last building to be constructed for maritime use. It contains toilets, change rooms, kitchen and office spaces as well as storage and works area.		
51*	1969	Wharf Mooring Floating Plant	Partially demolished	Poor

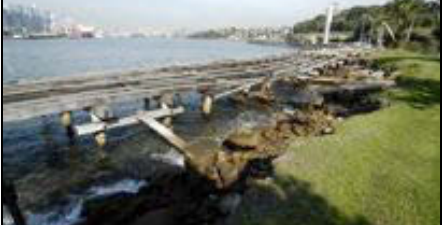
<p>The eastern wharf (more correctly the southern wharf) contrasted to the northern wharf structure in that it was freestanding from the shore with connecting access ramps. The wharf was constructed of 350 mm diameter piles, 350 x 350mm headstocks, 300 x 250 girders, raking piles, a 250 x 300mm kerb, bollards, square timber fenders on every second pile, all laid out on a 3 metre square grid with an overall width of 6 metres.</p> <p>The area between the wharf and the shore was backfilled over time with debris that now encroaches well under the former structure and which has eroded. The wharf is in very poor condition and the later concrete decking has been removed over much of the wharf to reduce the risk of collapse. The western end of the structure retains its concrete decking and houses a stiff leg crane (mounted on the shore); this area is in sounder condition than the eastern end. The finger wharf extends from the western end of the structure.</p> <p>The wharf was braced back to the shore using a combination of round timber posts (approx 300x300mm)(used as beams) and unusual steel tie rods that may predate the present structure. The tie rods have a hinge (now rusted) that probably allowed for some movement in the wharf with its free standing form. The wharf was used for materials handling from ship to shore and for berthing of vessels that required access from a wharf in contrast to berthing on skeleton and finger wharfs.</p> <p>The southern end of the wharf is in deteriorated but fair condition, the northern end of the wharf has been demolished.</p>

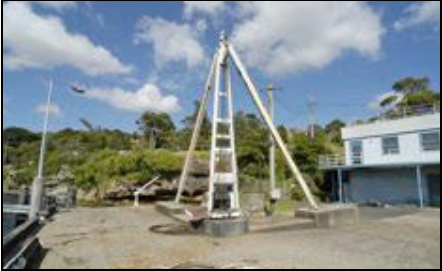
<p>A 1940s jib crane mounted on the 1945 wharf with stiff legs on a concrete base. The crane is typical of small cranes from the period.</p>	
118	Post 1914	Eroding shoreline	Deteriorating	Poor

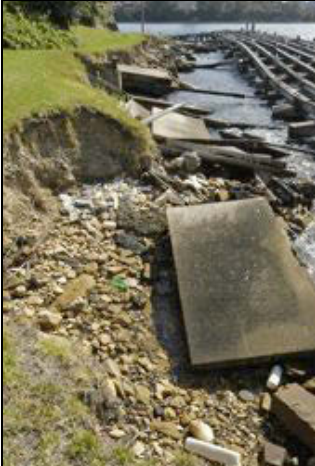
<p>The eastern shoreline behind the eastern wharf has been progressively filled with building materials and debris probably for the last 90+ years. Unlike the northern wharves sea walls were not used to contain material. The shoreline is severely eroding and will in time return to the original rock shoreline.</p>

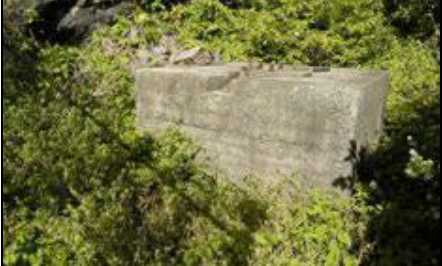
<p>The mass concrete mounting blocks for the 1914 period crane set over the first wharf and quarry base. Only two of the three bases remain, one being removed for the Port Services Building construction. They have holding down bolts for the steel superstructure still in place.</p>		
129	c.1970s-1980s	Navigation maker	Reasonably intact	Fair

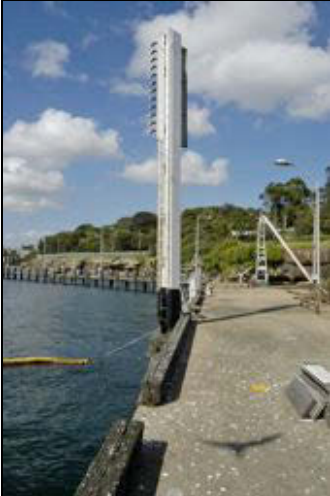
<p>Front lead beacon for commercial vessels approaching from the east. Steel structure with lights. Date not known but believed to be circa 1970s-1980s.</p>		
National Park Period				
-	-	-	-	-
